Boron hardening makes combine parts last longer

Modern combines have more power, which exerts greater pressure on the processing unit and creates new “weakest links.” Rasp bars, concaves, rotors and chopper blades wear faster. An Alberta company may have a solution — boron. ~ Ron Lyseng

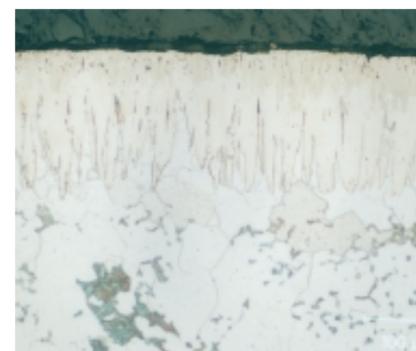
This photo of boronized metal, magnified 100 times, shows a 0.006” layer plus sawtooth penetration deeper into the metal.

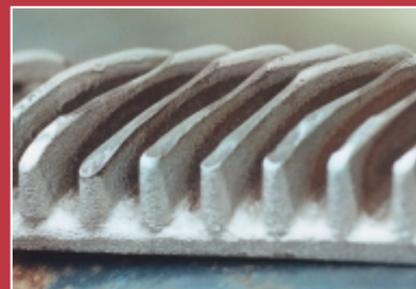
Chrome coating shows wear and surface chipping.

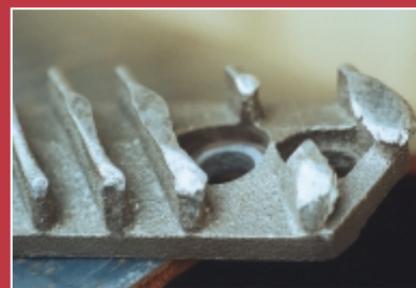
Boron-treated steel rub-bar after a rock impact.

Rocks through the combine will damage boron-treated surfaces, but they are more likely to pound small dents onto the surface than chip pieces of metal away.

Foster explains: "Rocks will still impact a boronized surface, but they usually make a dent and push the boron deeper into the part without chipping it off, so there's no loss of steel. That's the advantage of a hardening process that becomes part of the existing surface, compared to something like chrome that adds new material on top of the original surface. The deeper the boron is pounded into the surface, the less chance for chipping and loss of material. The sub-strata retains some resistance to abrasion."

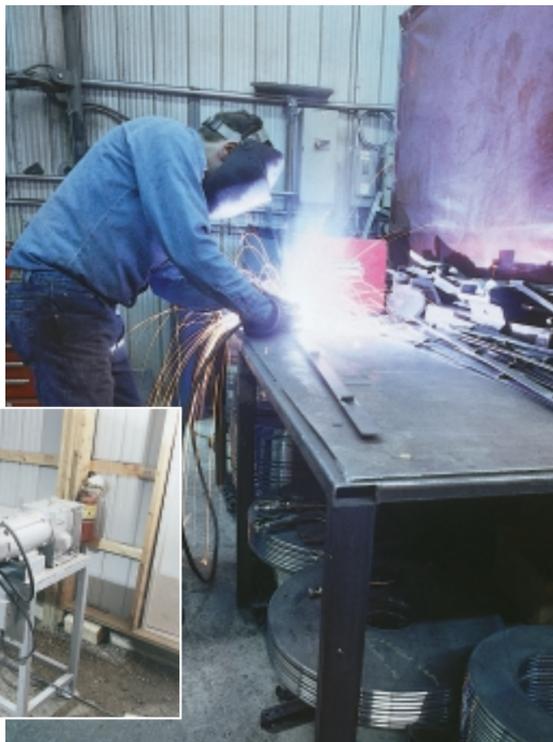
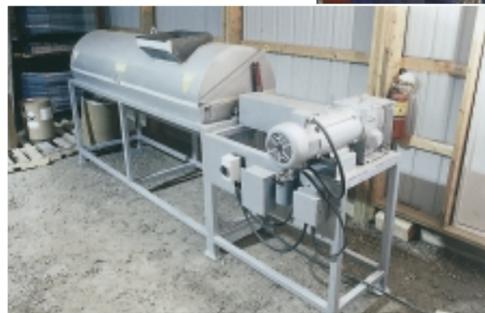
A welder at the company works on cylinder shims (below). Sunnybrook had to design its own polishing equipment to remove the boron crust from the finished parts. The machine allows the company to recover nearly all of the unused boron for recycling.

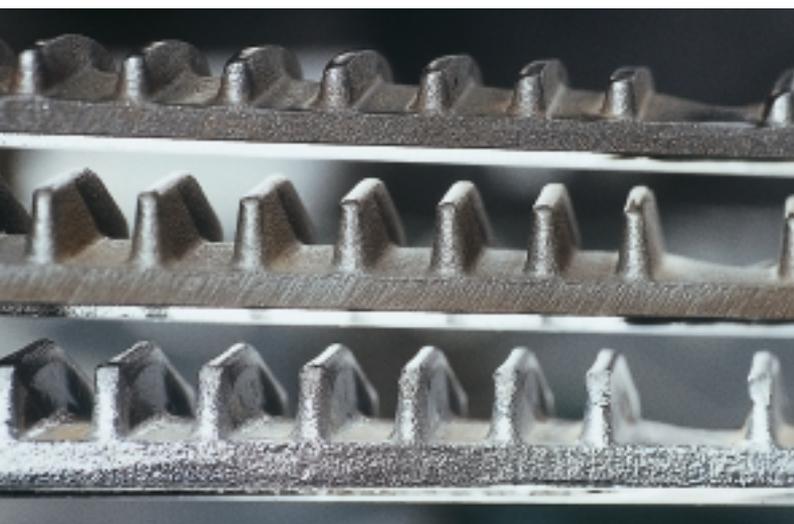
Top: Untreated worn steel.

Middle: Boronized, little wear.

Bottom: Chrome plated. Chrome chipped, cupping on vertical faces.

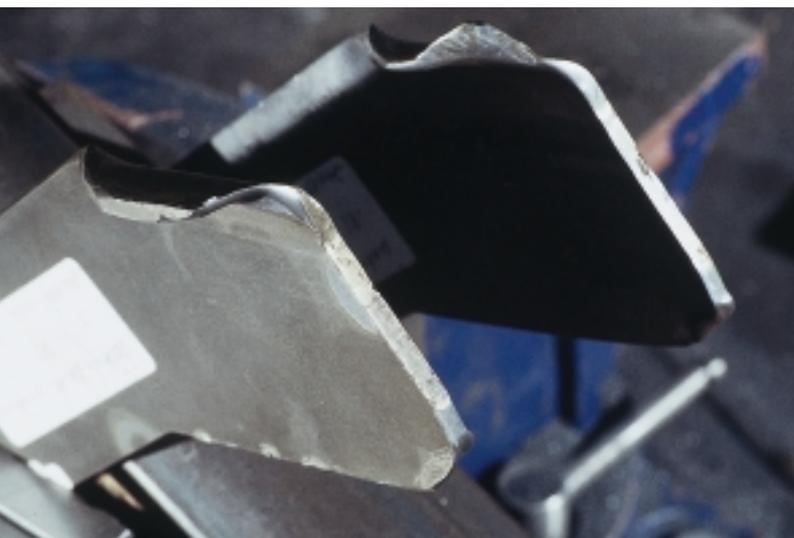
Top: Untreated worn face, thinned to bent over, with some rock dents.

Bottom: Boron treated, slight wear and some denting from rocks.
